# BRIDGE INSPECTION REPORT

INSPECTION TYPE: Routine Inspection - Municipal

COUNTY BUNCOMBE BRIDGE NUMBER 100528 INSPECTION CYCLE      YRS  
 ROUTE TEXAS ROAD ACROSS FLAT CREEK M.P. 0

SUPERSTRUCTURE TIMBER FLOOR ON I-BEAMS

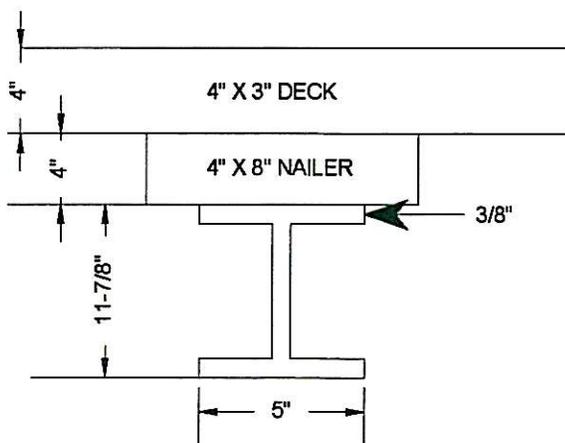
Title TYPICAL SECTION		Description TYPICAL SECTION	
Bridge No: 100528	Drawn By: ZEL	Date: 4/22/2008	File Name: S0298001021

NOTE: 7" X 4" X 1-1/8" STEEL PLATE  
ON BEAM 1 AND 6 AT ABUTMENT 1

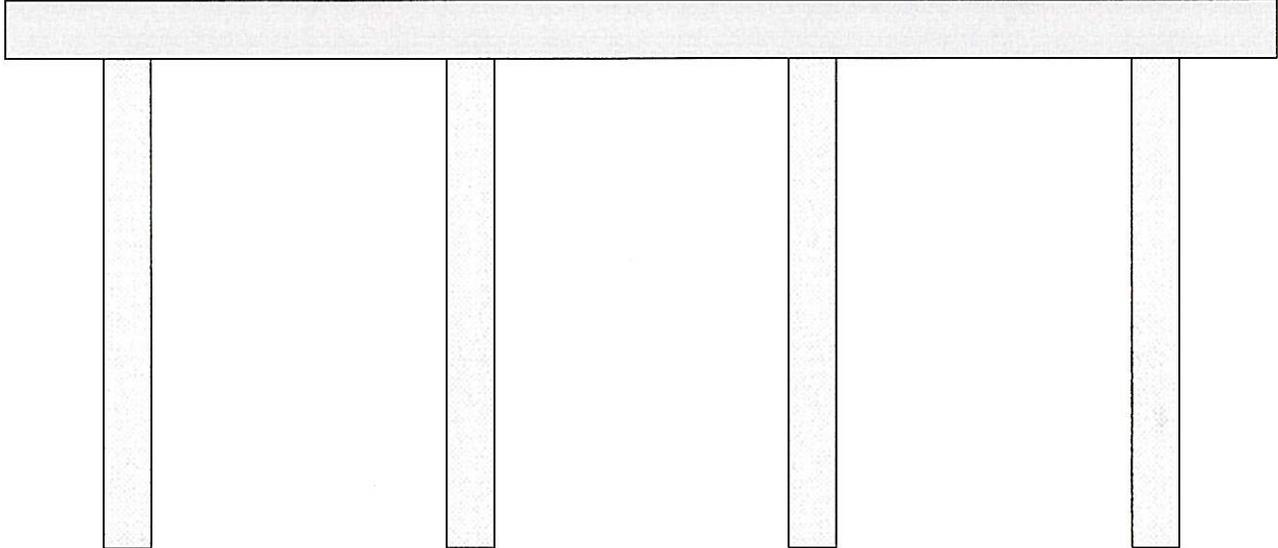
<b>Title</b> ABUTMENT 1		<b>Description</b> ABUTMENT 1			
<b>Bridge No:</b> 100528	<b>Drawn By:</b> ZEL	<b>Date:</b> 4/22/2008	<b>File Name:</b> S0298001022

Item No.	Grade	
35a	6	THE TIMBER CAP AT ABUTMENT 1 APPEARS NEWER THAN AT ABUTMENT 2. THE CAPS EXHIBIT MINOR SPLITTING WITH ONLY MINOR HAMMER PENETRATION.
35b	5	PILE 1 AT ABUTMENT 1 HAS DECAY 2 INCHES DEEP BY 24 INCHES HIGH ON THE NORTH FACE. THE REMAINDER OF THIS PILE APPEARS SOUND. PILE 4 AT ABUTMENT 2 HAS DECAY 2 INCHES DEEP BY 36 INCHES HIGH ON THE BACK SIDE AGAINST THE BULKHEAD. PILE 4 AT ABUTMENT 1 HAS DECAY ON THE NORTH FACE 18 INCHES HIGH BY 4 INCHES WIDE BY 2 INCHES DEEP. THE REMAINING PILES HAVE SOFTNESS AND DECAY UP TO 1/4 INCH DEEP FOR +/- 12 INCHES FROM THE BOTTOM, AS WELL AS MINOR DAMAGE FROM INSTALLATION.
35c	4	THE WINGWALLS ARE GENERALLY IN POOR CONDITION. ABOUT 75 PERCENT OF THE WINGWALL BOARDS AND 50 PERCENT OF THE WINGWALL PILES HAVE HEAVY TO COMPLETE DECAY. ALL OF THE BULKHEAD BOARDS HAVE SOFTNESS AND SOME DECAY. 50 PERCENT OF THE BOARDS HAVE DECAY UP TO 1/2 INCH DEEP AND 10 PERCENT OF BOARDS HAVE AREAS OF COMPLETE DECAY. ABOUT HALF OF THE ABUTMENT 2 BOARDS ARE STAINED WHITE AND SATURATED WITH WATER. THERE IS AN AREA AT ABUTMENT 2 BETWEEN PILES 1 AND 2 AND BETWEEN PILES 3 AND 4 WHERE A STEADY STREAM OF WATER IS FLOWING FROM BETWEEN THE BULKHEAD BOARDS. THERE IS A SLAB REPAIR BETWEEN PILES 3 AND 4 AT ABUTMENT 2 WHICH HAS HEAVY DECAY BOTH ABOVE AND BENEATH IT. THE SOLDIER PILES AT THE NORTHEAST AND NORTHWEST CORNERS HAVE HEAVY DECAY FOR ABOUT 1/2 OF THEIR HEIGHT. THE OTHER SOLDIER PILES HAVE HEAVY DECAY AT THE TOP 12 INCHES.
